**Flood Control Project Maintenance
Levee Inspections**

Maintenance Issue Types Only, Levee Inspection Report By Mile - Fall 2018

Sacramento Maintenance Yard West Levee Yolo Bypass

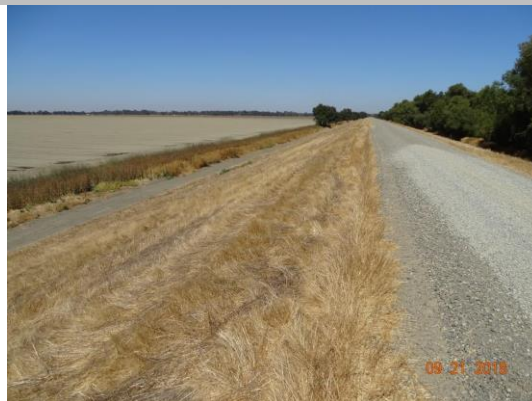
Photo 1 of 1 : FA_2018_ST0011_291_3_20180924_00017.jpg

LM Start	2.39	Rating **	A	Issue No.	3
LM End	2.39	Issue Type +	Ma	Location *	LS
Category	Earthen Levee			GPS Latitude/Longitude	
				Start	End
Item	Vegetation			38.726721°	38.726721°
				-121.660276°	-121.660276°
DWR ID	DWR_ST0011_01_f_2018_3				
Comment Code					
V1 : Control annual grass and weeds on the levee slopes and easements.					
Inspector Comment					
Sac Yard maintains the vegetation at a high level.

View of the mowed landside slope. Fall 2018.

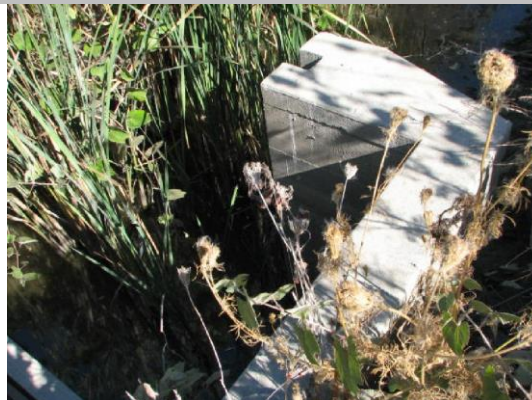
Photo 3 of 3 : UCIP_FA_2018_53232_60302.jpg

Comment Code						
Inspector Comment						
FS_ID:53232						
DS_ID:17742						
EP_NO: 10284						
Repair Type: No Action Needed						
Crossing Status: Found						
UCIP Comments: Screw gates where removed and pipe was abandoned by farmer, How pipe was abandoned is unknown. Pipe is Grouted						
FIELD_STRUCT_DESC: 1 of 2: 42-inch corrugated metal gravity drainage pipe through the levee, 23.6 feet below the crown. Slide gate on the waterside (WS) slope. Concrete distribution box at the landside (LS) toe. (42-inch pipe [HLM 2.63] authorized under Automatic Board Order (ABO) issued as Permit No. 10284, 1974 - La Borda and Hoover). [Additional Reference(s): DWR Levee Log, 2004. USACE Sacramento O&M Manual 127, June 1953, (Station 133+82)].						
FS Date: 11/16/2018 2:17:55 PM

Landside view: side of concrete spillbox/headwall

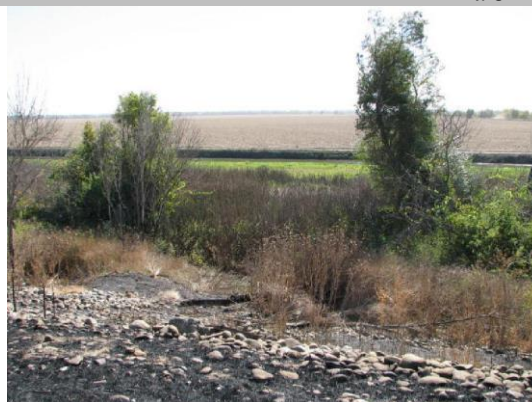
Photo 1 of 3 : UCIP_FA_2018_53233_60309.jpg

Comment Code						
Inspector Comment						
FS_ID:53233 DS_ID:17747 EP_NO: 10284 Repair Type: No Action Needed Crossing Status: Found UCIP Comments: No slide gate found. slide gates and pipes were abandon by farmer, how unknown FIELD_STRUCT_DESC: 2 of 2: 42-inch corrugated metal gravity drainage pipe through the levee, 23.6 feet below the crown. Slide gate on the waterside (WS) slope. Concrete distribution box at the landside (LS) toe. (42-inch pipe [HLM 2.63] authorized under Automatic Board Order (ABO) issued as Permit No. 10284, 1974 - La Borda and Hoover). [Additional Reference(s): DWR Levee Log, 2004. USACE Sacramento O&M Manual 127, June 1953, (Station 133+82)]. FS Date: 11/16/2018 2:19:35 PM

Waterside view: overview

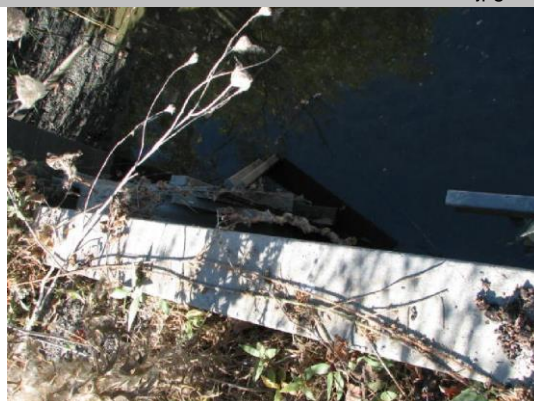
Photo 2 of 3 : UCIP_FA_2018_53233_60308.jpg

FS_ID:53233
DS_ID:17747
EP_NO: 10284
Repair Type: No Action Needed
Crossing Status: Found
UCIP Comments: No slide gate found. slide gates and pipes were abandon by farmer, how unknown
FIELD_STRUCT_DESC: 2 of 2: 42-inch corrugated metal gravity drainage pipe through the levee, 23.6 feet below the crown. Slide gate on the waterside (WS) slope. Concrete distribution box at the landside (LS) toe. (42-inch pipe [HLM 2.63] authorized under Automatic Board Order (ABO) issued as Permit No. 10284, 1974 - La Borda and Hoover). [Additional Reference(s): DWR Levee Log, 2004. USACE Sacramento O&M Manual 127, June 1953, (Station 133+82)].
FS Date: 11/16/2018 2:19:35 PM

Landside view: concrete spill box

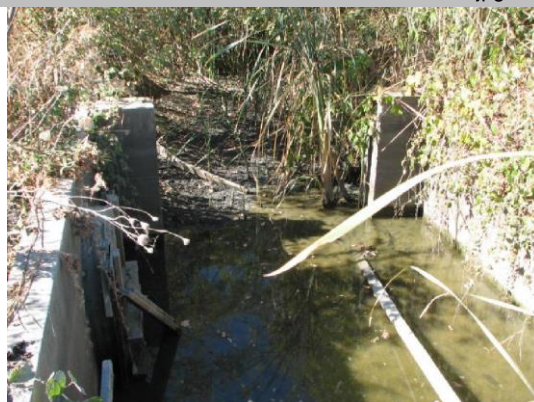
Photo 3 of 3 : UCIP_FA_2018_53233_60307.jpg

Landside view: CM pipe with flap gate

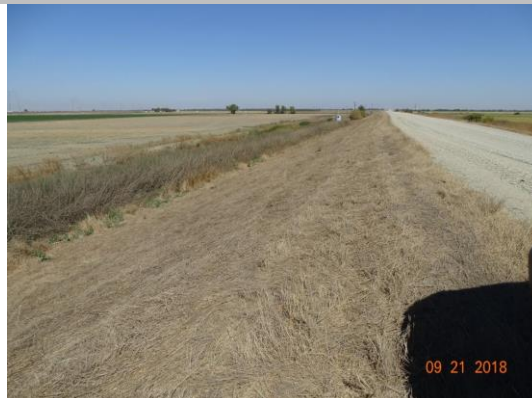
Photo 1 of 1 : FA_2018_ST0011_292_1_20180924_00006.jpg

LM Start	1.43	Rating **	A	Issue No.	1
LM End	1.43	Issue Type +	Ma	Location *	LS
Category	Earthen Levee			GPS Latitude/Longitude	
				Start	End
Item	Vegetation			38.699928 °	38.699928 °
				-121.674070 °	-121.674070 °
DWR ID	DWR_ST0011_02_f_2018_1				
Comment Code					
V1 : Control annual grass and weeds on the levee slopes and easements.					
Inspector Comment					
Sac Yard maintains the vegetation at a high level.

View of the mowed landside slope. Fall 2018.

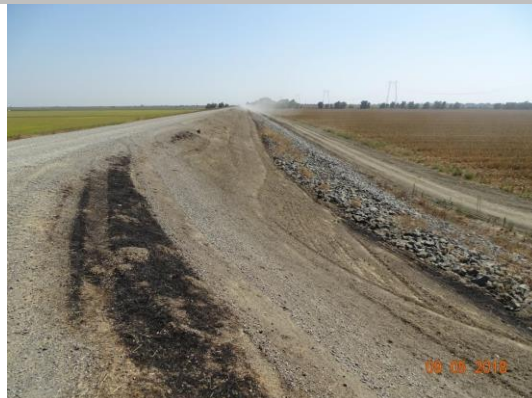
Photo 1 of 1 : FA_2018_ST0011_293_2_20180905_00004.jpg

LM Start	0.01	Rating **	A	Issue No.	2
LM End	0.01	Issue Type +	Ma	Location *	LS
Category	Earthen Levee			GPS Latitude/Longitude	
				Start	End
Item	Vegetation			38.698383°	38.698383°
				-121.674109°	-121.674109°
DWR ID	DWR_ST0011_03_f_2018_2				
Comment Code					
V1 : Control annual grass and weeds on the levee slopes and easements.					
Inspector Comment					
The Sacramento Maintenance Yard continues to maintain the vegetation at an exceptional level.

View of the recently burned and dragged landside slope. Fall 2018.

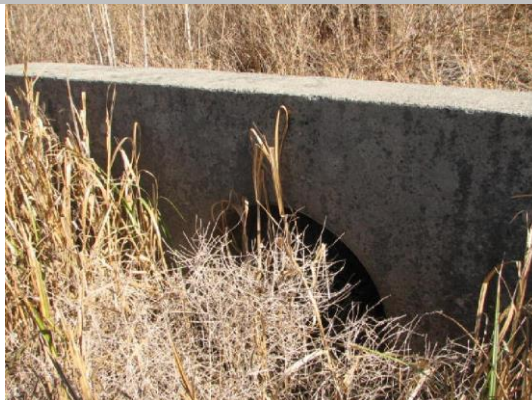
Photo 1 of 3 : UCIP_FA_2018_44826_60517.jpg

LM Start	0.60	Rating **	A/W	Issue No.	20
LM End	0.60	Issue Type +	Ma	Location *	
Category	Supplemental			GPS Latitude/Longitude	
				Start	End
Item	DWR UCIP LMA Responsibility			38.565704 °	38.565704 °
				-121.638650 °	-121.638650 °
DWR ID	528				
Comment Code					
Inspector Comment					
FS_ID:44826 DS_ID:528 EP_NO: 10304 Repair Type: No Action Needed Crossing Status: Found UCIP Comments: FIELD_STRUCT_DESC: 30-inch corrugated metal gravity drainage pipe through the levee, 22 feet below the crown. Flap gate on the waterside (WS) end. (30-inch pipe [HLM 0.59] authorized under Automatic Board Order (ABO) issued as Permit No. 10304, 1974 - Southern Pacific Transportation Company). [Additional Reference(s): DWR Levee Log, 2004. USACE Sacramento O&M Manual 120, June 1952, (Station 446+08)]. FS Date: 4/28/2015 2:58:55 PM

Landside view: concrete headwall.

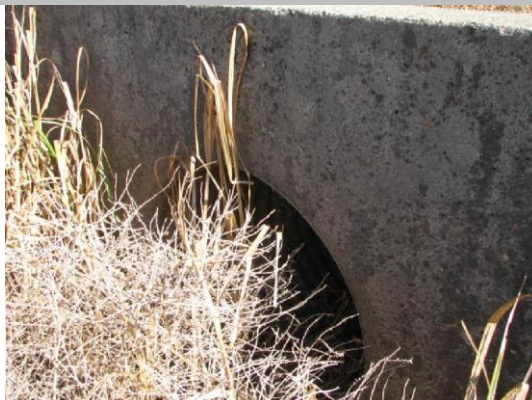
Photo 2 of 3 : UCIP_FA_2018_44826_60516.jpg

Landside view: closer look at the headwall.

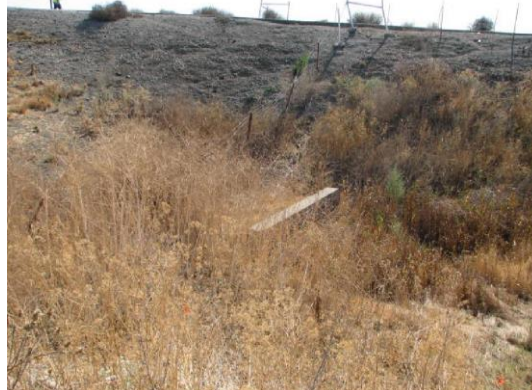
Photo 3 of 3 : UCIP_FA_2018_44826_60520.jpg

LM Start	0.60	Rating **	A/W	Issue No.	20 (cont)	
LM End	0.60	Issue Type +	Ma	Location *		
Category	Supplemental			GPS Latitude/Longitude		
				Start		End
Item	DWR UCIP LMA Responsibility			38.565704 °		38.565704 °
				-121.638650 °		-121.638650 °
DWR ID	528					
Comment Code						
Inspector Comment						
FS_ID:44826 DS_ID:528 EP_NO: 10304 Repair Type: No Action Needed Crossing Status: Found UCIP Comments: FIELD_STRUCT_DESC: 30-inch corrugated metal gravity drainage pipe through the levee, 22 feet below the crown. Flap gate on the waterside (WS) end. (30-inch pipe [HLM 0.59] authorized under Automatic Board Order (ABO) issued as Permit No. 10304, 1974 - Southern Pacific Transportation Company). [Additional Reference(s): DWR Levee Log, 2004. USACE Sacramento O&M Manual 120, June 1952, (Station 446+08)]. FS Date: 4/28/2015 2:58:55 PM

Landside view: overview

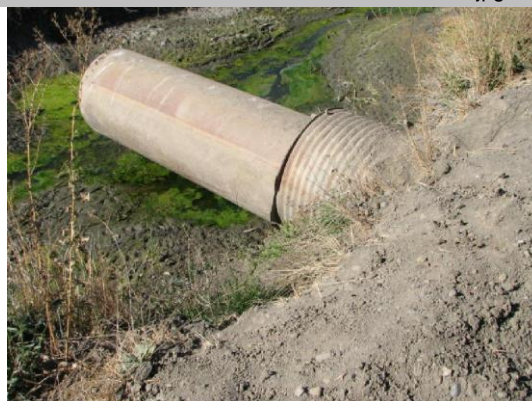
Photo 1 of 3 : UCIP_FA_2018_44822_24980.jpg

Comment Code						
Inspector Comment						
FS_ID:44822 DS_ID:17736 EP_NO: 10306 Repair Type: No Action Needed Crossing Status: Found UCIP Comments: Farmer cleans this screw gate every year FIELD_STRUCT_DESC: 48-inch corrugated metal gravity drainage pipe through the levee, 21.5 feet below the crown. 42-inch steel pipe inside the 48-inch pipe. Flap gate on the waterside (WS) with two cutoff walls, one headwall, and one saddle and apron. (48-inch pipe [HLM 2.12] authorized under Automatic Board Order (ABO) issued as Permit No. 10306, 1974 - Wells Fargo Bank, Trustees for Cowell Foundation). [Additional Reference(s): USACE Sacramento O&M Manual 119, December 1952, (Station 80+00)]. FS Date: 4/28/2015 2:57:49 PM

Landside view: 42-inch steel pipe inside a 48-inch CMP

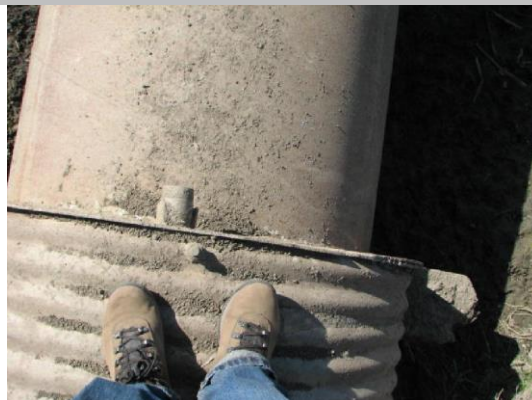
Photo 2 of 3 : UCIP_FA_2018_44822_24979.jpg

Landside view: closer look at 42-inch steel pipe and 48-inch CMP

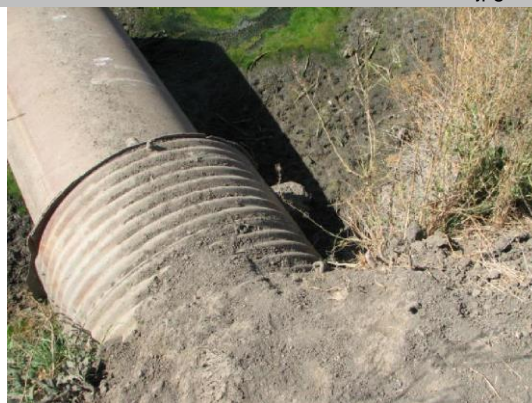
Photo 3 of 3 : UCIP_FA_2018_44822_24978.jpg

Comment Code						
Inspector Comment						
FS_ID:44822 DS_ID:17736 EP_NO: 10306 Repair Type: No Action Needed Crossing Status: Found UCIP Comments: Farmer cleans this screw gate every year FIELD_STRUCT_DESC: 48-inch corrugated metal gravity drainage pipe through the levee, 21.5 feet below the crown. 42-inch steel pipe inside the 48-inch pipe. Flap gate on the waterside (WS) with two cutoff walls, one headwall, and one saddle and apron. (48-inch pipe [HLM 2.12] authorized under Automatic Board Order (ABO) issued as Permit No. 10306, 1974 - Wells Fargo Bank, Trustees for Cowell Foundation). [Additional Reference(s): USACE Sacramento O&M Manual 119, December 1952, (Station 80+00)]. FS Date: 4/28/2015 2:57:49 PM

Landside view: closer look at 42-inch steel pipe and 48-inch CMP

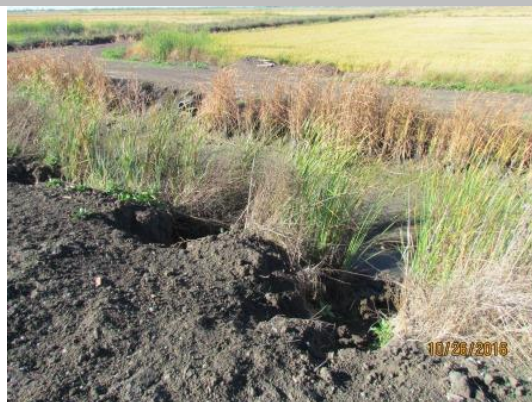
Photo 1 of 2 : FA_2018_ST0011_294_19_20180904_00007.jpg

LM Start	2.11	Rating **	A/W	Issue No.	19
LM End	2.11	Issue Type +	Ma	Location *	LS
Category	Earthen Levee			GPS Latitude/Longitude	
				Start	End
Item	Erosion / Bank Caving			38.545430 °	38.545430 °
				-121.631211 °	-121.631211 °
DWR ID	DWR_ST0011_04_f_2016_19				
Comment Code					
E1 : Note and monitor erosion site.					
Inspector Comment					
It appears that the ditch is beginning to erode the landside levee toe, but is not within the levee prism. Recommend monitoring.

Closer view of erosion. Fall 2016.

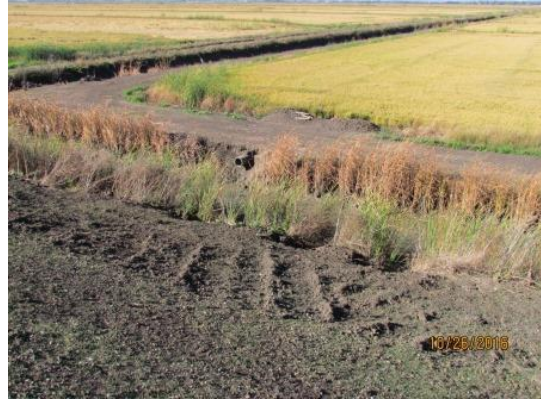
Photo 2 of 2 : FA_2018_ST0011_294_19_20180904_00008.jpg

LM Start	2.11	Rating **	A/W	Issue No.	19 (cont)
LM End	2.11	Issue Type +	Ma	Location *	LS
Category	Earthen Levee			GPS Latitude/Longitude	
				Start	End
Item	Erosion / Bank Caving			38.545430 °	38.545430 °
				-121.631211 °	-121.631211 °
DWR ID	DWR_ST0011_04_f_2016_19				
Comment Code					
E1 : Note and monitor erosion site.					
Inspector Comment					
It appears that the ditch is beginning to erode the landside levee toe, but is not within the levee prism. Recommend monitoring.

View of erosion on landside levee slope. Fall 2016.

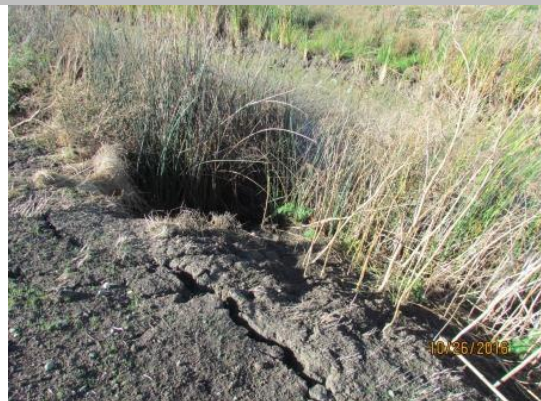
Photo 1 of 2 : FA_2018_ST0011_294_17_20180904_00005.jpg

LM Start	2.14	Rating **	A/W	Issue No.	17
LM End	2.14	Issue Type +	Ma	Location *	LS
Category	Earthen Levee			GPS Latitude/Longitude	
				Start	End
Item	Erosion / Bank Caving			38.545022 °	38.545022 °
				-121.631209 °	-121.631209 °
DWR ID	DWR_ST0011_04_f_2016_17				
Comment Code					
E1 : Note and monitor erosion site.					
Inspector Comment					
It appears that the ditch is beginning to erode the landside levee toe, but is not within the levee prism. Recommend monitoring.

Closer view of erosion. Fall 2016.

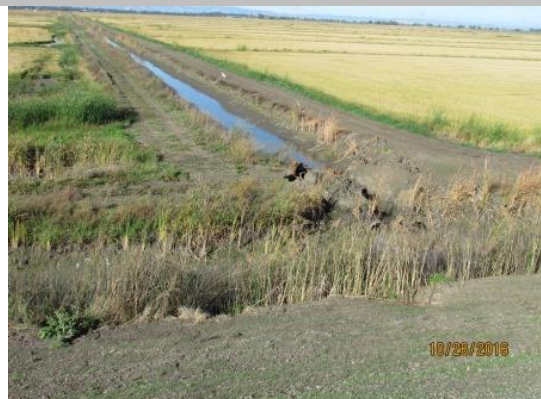
Photo 2 of 2 : FA_2018_ST0011_294_17_20180904_00006.jpg

View of erosion at landside levee toe. Fall 2016.

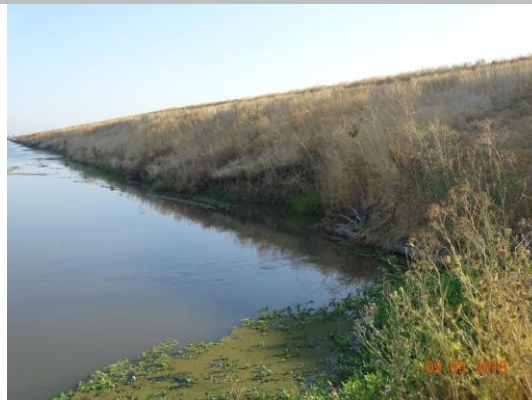
Photo 1 of 1 : FA_2018_ST0011_294_13_20180905_00018.jpg

LM Start	3.61	Rating **	M	Issue No.	13
LM End	3.61	Issue Type +	Ma	Location *	LS
Category	Earthen Levee			GPS Latitude/Longitude	
				Start	End
Item	Erosion / Bank Caving			38.523683 °	38.523683 °
				-121.631463 °	-121.631463 °
DWR ID	DWR_ST0011_04_f_2018_13				
Comment Code					
E2 : Schedule repair of erosion site prior to the next inspection.					
Inspector Comment					
Erosion on the landside toe because of irrigation canal. Sac Yard is aware of the issue and intends to fix it.

View of erosion on the landside slope adjacent to irrigation canal. Fall 2018.
